An Investigation on Coconut-timber Waste as Construction Material for Earthquake Resistant Wooden House in North Sulawesi, Indonesia

Rilya Rumbayan¹, Donny Taju², Rudolf Mait³

1, 2, 3 Senior Lecturer, Department of Civil Engineering, Manado State Polytechnic, Indonesia

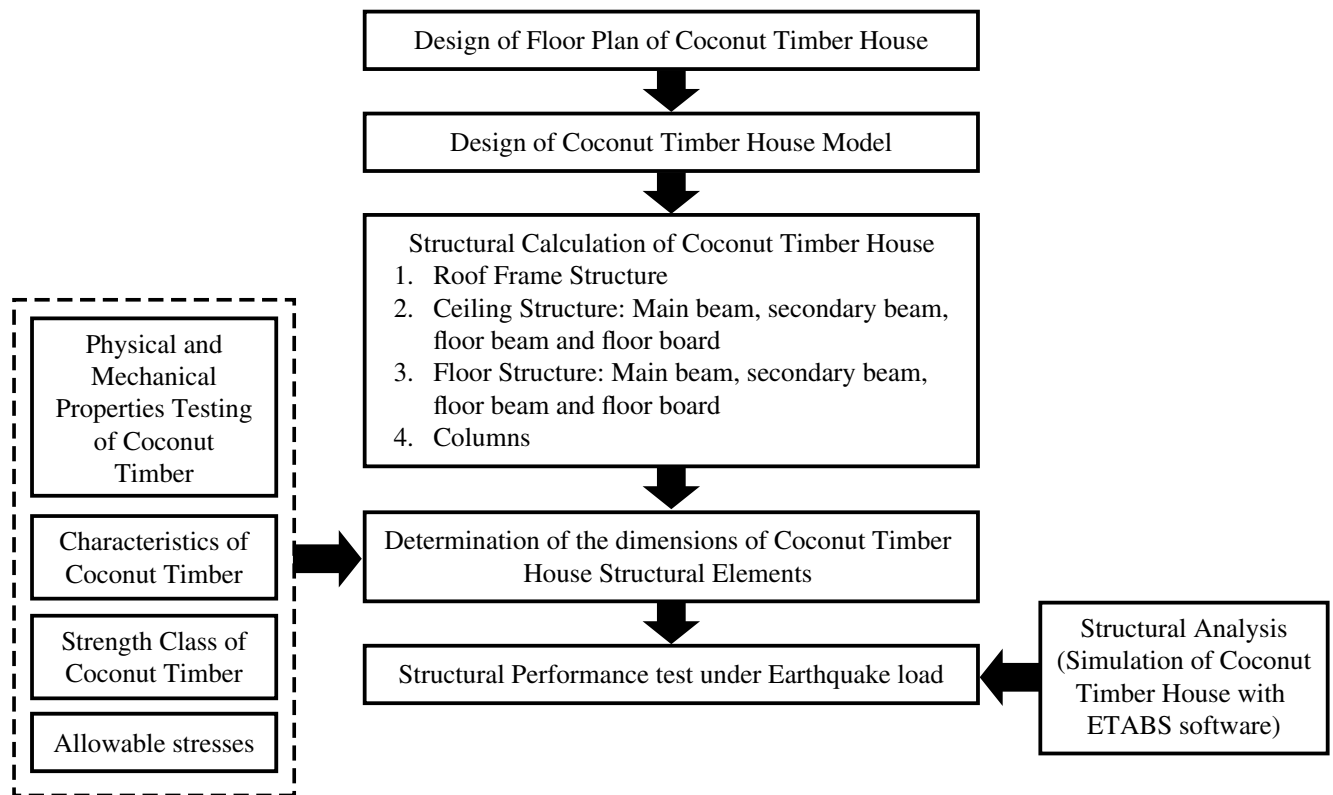
Fig. 1. Research Method

Research methods (Figure 1) comprise of laboratory tests, design of coconut-timber house prototype that is resistant to earthquake and performance test of the prototype of coconut-timber house under earthquake load.

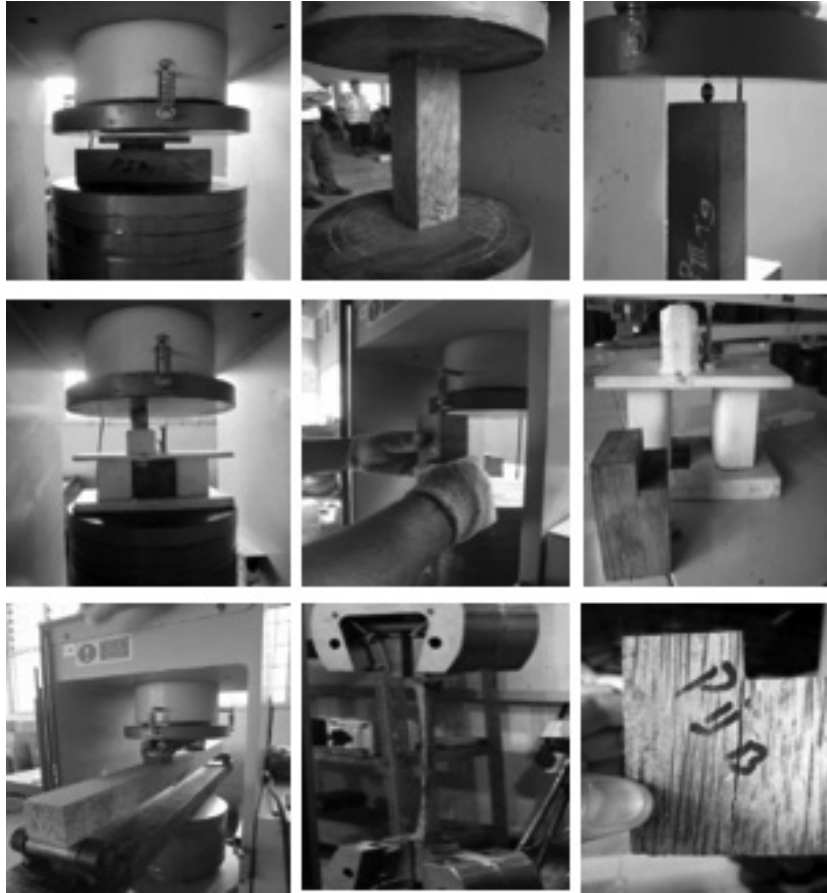
The experimental stage in the laboratory consists of physical and mechanical properties tests which cover moisture content test, density test, tensile test parallel to grain, compression test parallel to grain, compression test perpendicular to grain, shear strength parallel to grain, flexural test, and toughness (Figure 2). Samples for the tests were obtained from unproductive

Fig. 2. Mechanical properties tests of coconut-timber at the Material Testing Laboratory, Manado State Polytechnic

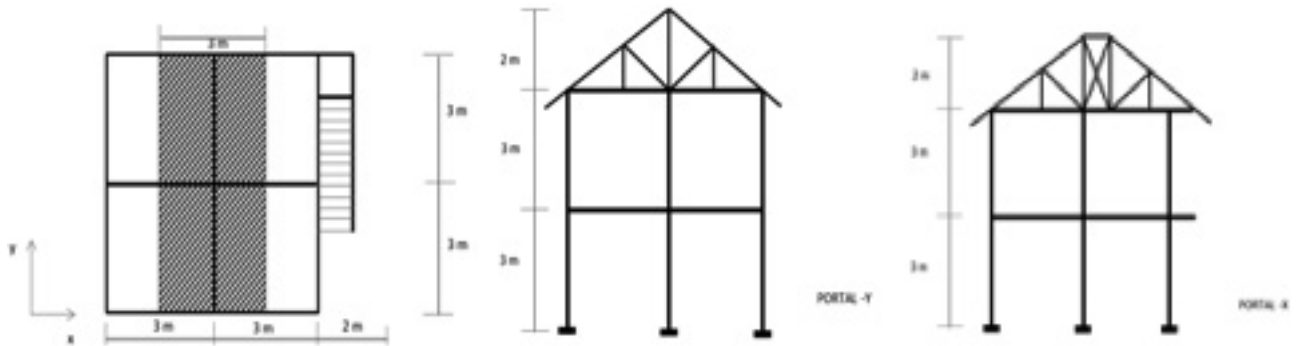
Results of structural design of a coconut-timber house with a floor plan size of 6 m x 6 m are shown in **Figure 3**.

Fig. 3. Design of coconut-timber house: (A). Floor Plan; (B). Portal Frame X-axis; and (C). Portal Frame Y-axis.

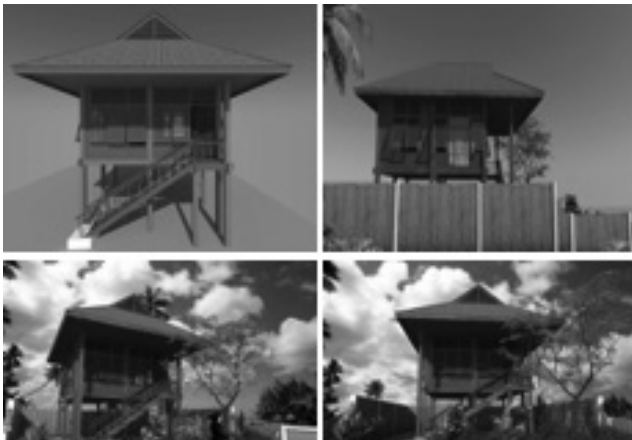
The result of the design of a coconut-timber house model is shown in **Figure 4**.

Fig. 4. Design drawing and model of coconut-timber house.

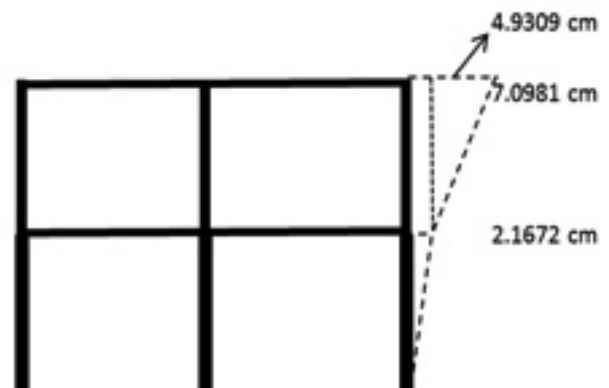
software used for this simulation process is ETABS (Structural software for building analysis and design). The sway mode caused by earthquake on the frame structure of coconut-timber house generated by ETABS software can be seen in Figure 5. Result from the structural analysis of the frame structure of coconut-timber house under earthquake load with ETABS software shows that the construction is safe under earthquake load.

Fig. 5. Sway mode due to earthquake load acting on the frame structure of coconut-timber house (generated with ETABS)
